## PROPERTIES OF THERMIT WELDED JOINTS IN REINFORCING BARS

Test No. 8 - 515 Contract No. 57-13 North Fork Crossing Date: 7-18-58

### Thermit Welding of Reinforcing Bars

Thermit welding of #18 reinforcing bars for procedure test for Contract Specification No. 57-13, Bridge at North Fork Crossing, Feather River.

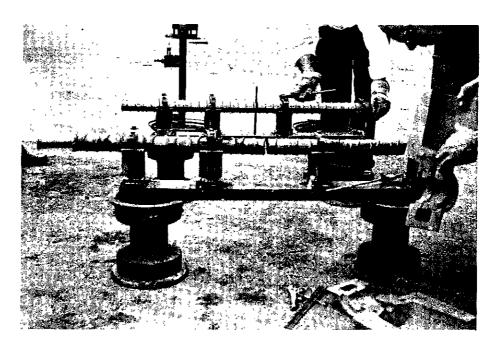
Picture No. 1

The aligning and spacing of the reinforcing bars. The spacing of the reinforcing bars is very important to allow the molten metal to wash through the space for fusion.

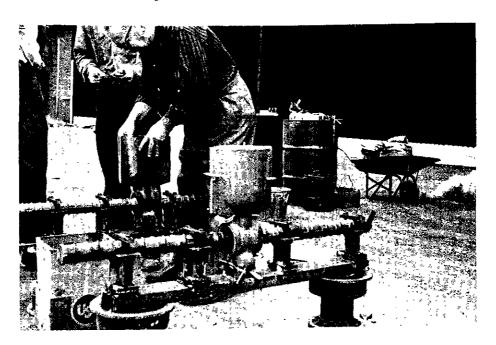
Picture No. 2

The thermit crucible is then clamped on the aligned and properly spaced reinforcing bars.

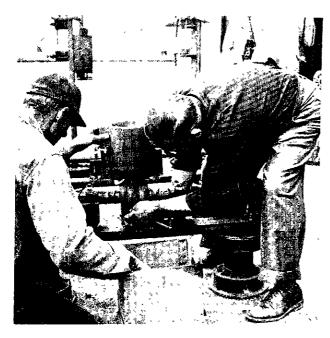
#### Picture No. 3

The thermit crucible is then packed with a luting sand in the luting area of the crucible mold. The luting or packing of the sand around the reinforcing bar is very important. If the sand is too dry, coarse, or not properly placed, the weld metal will burst out of the mold causing a defective weld.

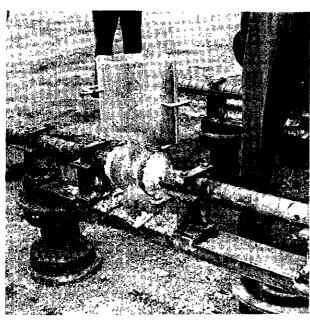
#### Picture No. 4

Here can be seen a thermit crucible packed with luting sand and ready for igniting.

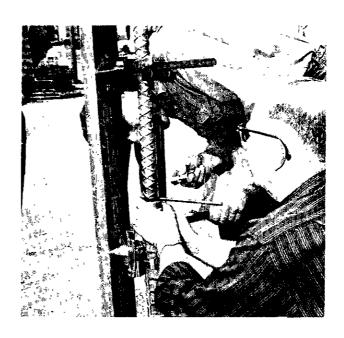
Picture No. 1

The reinforcing bars are oxyacetylene cut square. It is very important not to have a rough cut or lack of fusion will result. The reinforcing bars are then put into a jig and properly spaced.

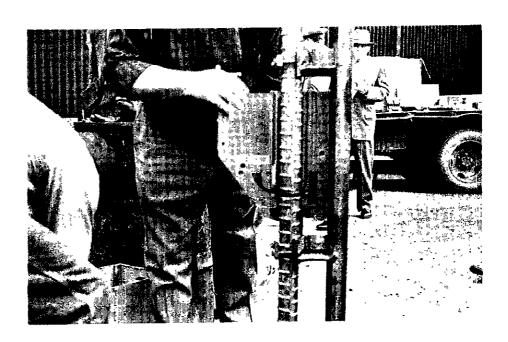
Picture No. 2

The crucible mold is then placed on the reinforcing bars with the tapping gate lined up with the bar spacing.

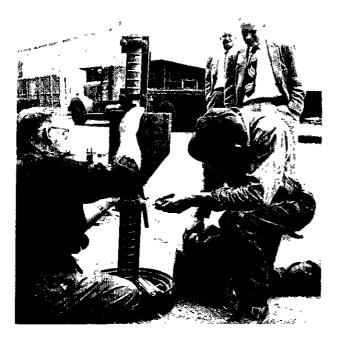
#### Picture No. 3

The mold and reinforcing bar is then packed with a luting sand. This is very important. If not properly packed, the weld metal will run out between the mold and reinforcing bar causing a defective weld.

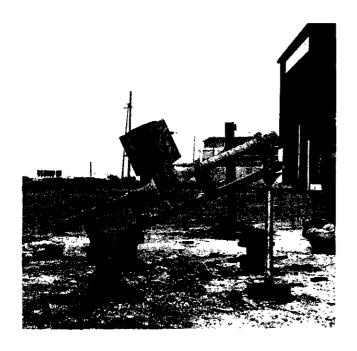
Reinforcing bar tilted on 25° angle, with crucible mold and sand luting in place ready for igniting.

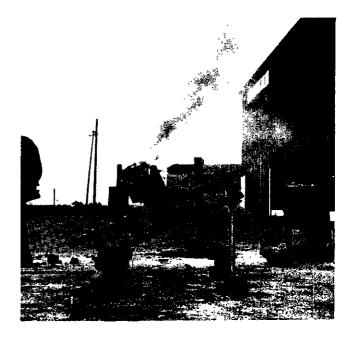
Picture No. 2

Thermit ignited and reaction taken place. All molds were allowed to cool down before stripping.

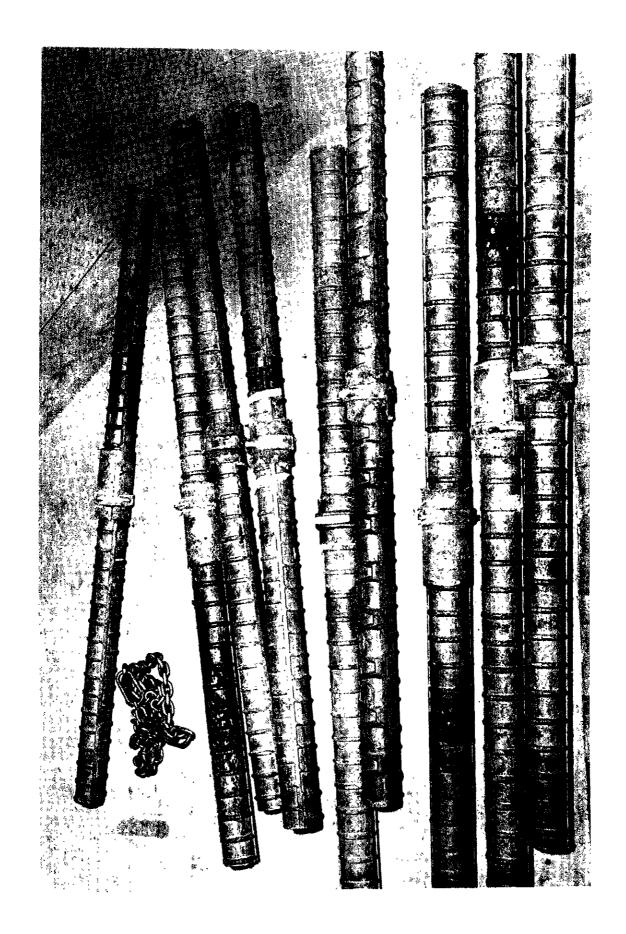
The typical vertical and horizontal thermit welds with the tapping gates and risers knocked off, ready for testing.

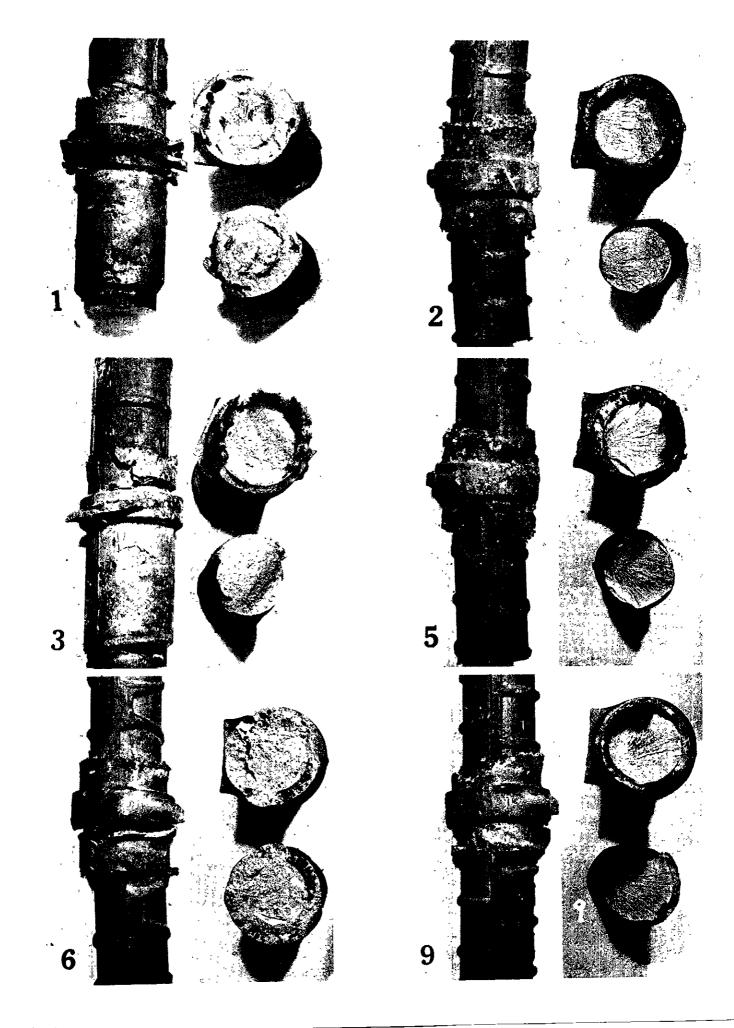
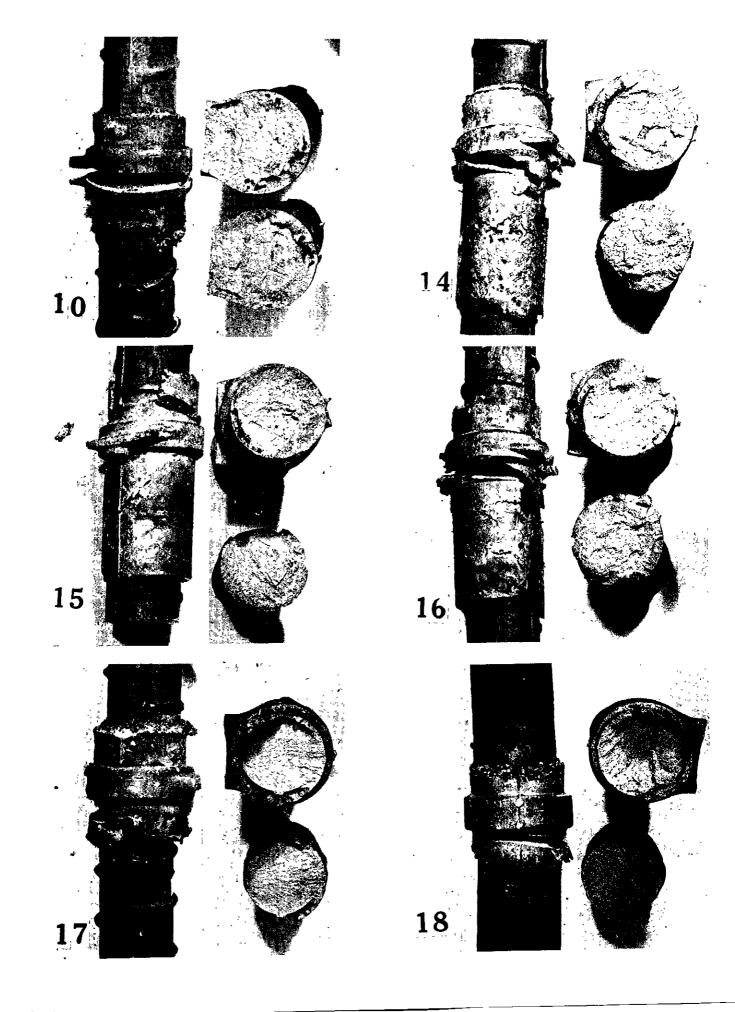
Thermit weld break locations.

Test Bars	Break Location
#1	Weld metal.
#2 Beam Test	Junction of weld metal and parent metal where the extreme notch is located from weld and weld-flashing.

#3 Beam Test	Junction of weld metal and parent metal where the extreme notch is located from weld and weld-flashing.
<b>#</b> 4	Junction of weld metal and parent metal where the extreme notch is located from weld and weld-flashing.

#6	Weld metal.
#9	Junction of weld metal and parent metal where the extreme notch is located from weld and weld-flashing.
#10	Weld metal.
#14	Junction of weld metal and parent metal where the extreme notch is located from weld and weld-flashing.

#15	Junction of weld metal and parent metal where the extreme notch is located from weld and weld-flashing.
#16	Weld metal and parent metal.
#17	Junction of weld metal and parent metal where the extreme notch is located from weld and weld-flashing.
<b>#</b> 18	Junction of weld metal and parent metal where the extreme notch is located from weld and weld-flashing.

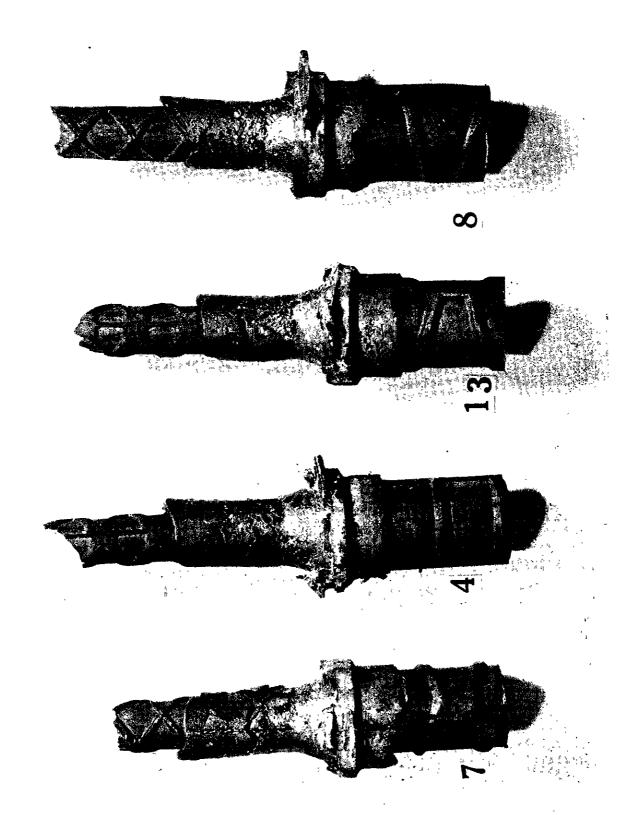
All thermit welded reinforcing bars of number 18 size cars to number 11 bars broke in the number 11 bars, abbrokettely 6 inches from center of thermit weld.

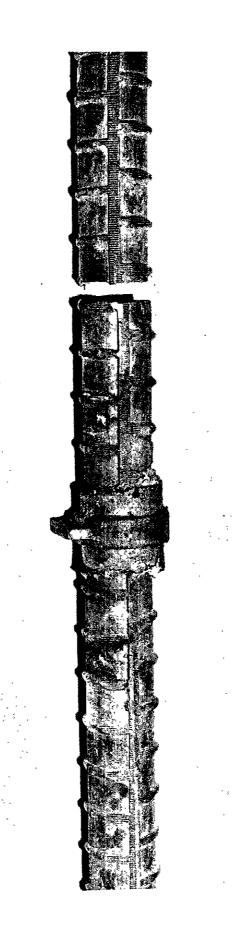
Remarks: Broke out of weld. Special Thermit Compound S.A.E. 1040.

Preheated #18 Reinforcing Bar The Pacific States bar previously welded and broken and rewelded on opposite ends which were saw cut and preheated to 600° F. on each side of thermit weld for 6 to 8 inches.
